Introduction

Thank you for designing with the Xilinx XA Zynq®-7000 Automotive family of devices. Although Xilinx has made every effort to ensure the highest possible quality, the devices listed in [Table 1](#) are subject to the limitations described in the following errata.

Table 1: Devices Affected by These Errata

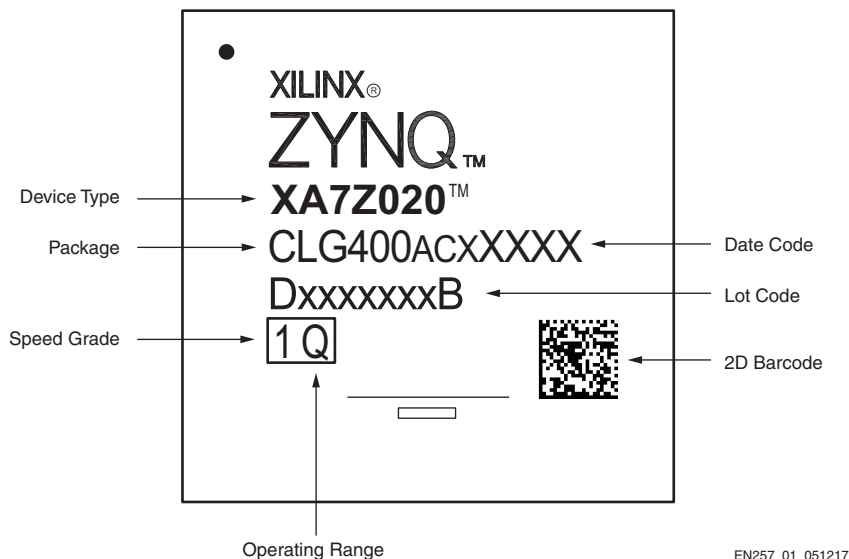
Figure 1: Example Device Top Mark

Figure 1 shows an example device top mark for the device listed in Table 1. Refer to [XCN16014](#) for details on the addition of the 2D barcode.

Date	Version	Description of Revisions
09/11/2017	1.5	Updated Traceability and Figure 1 with 2D barcode information.
10/19/2015	1.4	Added Under Very Rare Timing Circumstances, Transition Into Streaming Mode Might Create A Data Corruption and When ECC Is Enabled, The CHE_CORR_ECC_ADDR_REG_OFFSET Register Might Report An Incorrect Column Address .
03/16/2015	1.3	Added I2C Master Generates Invalid Read Transactions and I2C Transaction Corruption In Slave Receiver Mode .
10/01/2014	1.2	Added Glitch Filter In I2C Fast Mode Not Implemented .
08/28/2014	1.1	Added XC7Z030 to Table 1 . Added the I2C section: I2C Master Generates Invalid Read Transactions ; Missing I2C Master Completion Interrupt ; I2C Violates t_{HD,STA} Requirement For Standard-Mode When It Runs Faster Than 90 kHz ; I2C Violates t_{LOW} Requirement For Fast-Mode When It Runs Faster Than 384 kHz ; I2C Violates t_{BUF} Requirement For Fast-Mode When It Runs Faster Than 384 kHz ; and I2C Missing Arbitration On Repeated Start . Added the QSPI section: QSPI RxFIFO Not Empty Status Is Not Updated Promptly ; and QSPI Controller Reports Wrong "Busy Status" Of Flash Memories In Dual Parallel Configuration When Auto CS And "Divide by 2" Baud Rate Is Used . Added SDIO section: ADMA2 Burst Transactions Alignment And Length Requirements ; Software Reset Sequence For SDIO Can Hang The Interconnect ; Second CMD12 Can Be Issued If Auto CMD12 Is Enabled ; ADMA2 Mode Fails To Release Properly When Abort CMD Is Issued ; Transfer Complete Asserts Before Completing Busy Due To CMD13 ; and CMD13 Not Handled Properly When CMD19 Is In Progress . Also added: SMC Parallel (SRAM/NOR) Interface Does Not Correctly Assert CS0 For 64 MB Memories ; SMC Parallel (SRAM/NOR) Interface Address Bit 25 Is Inverted For 64 MB Memories . Added the SPI section: RxFIFO Not Empty Status Is Not Updated Promptly .
